**AMENDMENT #1 TO TSCA RISK-BASED CLEAN-UP OF PCBs  
(FIELD ADMINISTRATION ONE STOP OFFICES RENOVATION)  
BERKSHIRE COMMUNITY COLLEGE  
1350 WEST STREET  
PITTSFIELD, MASSACHUSETTS**

ATC PROJECT 183DW20008

JULY 21, 2020

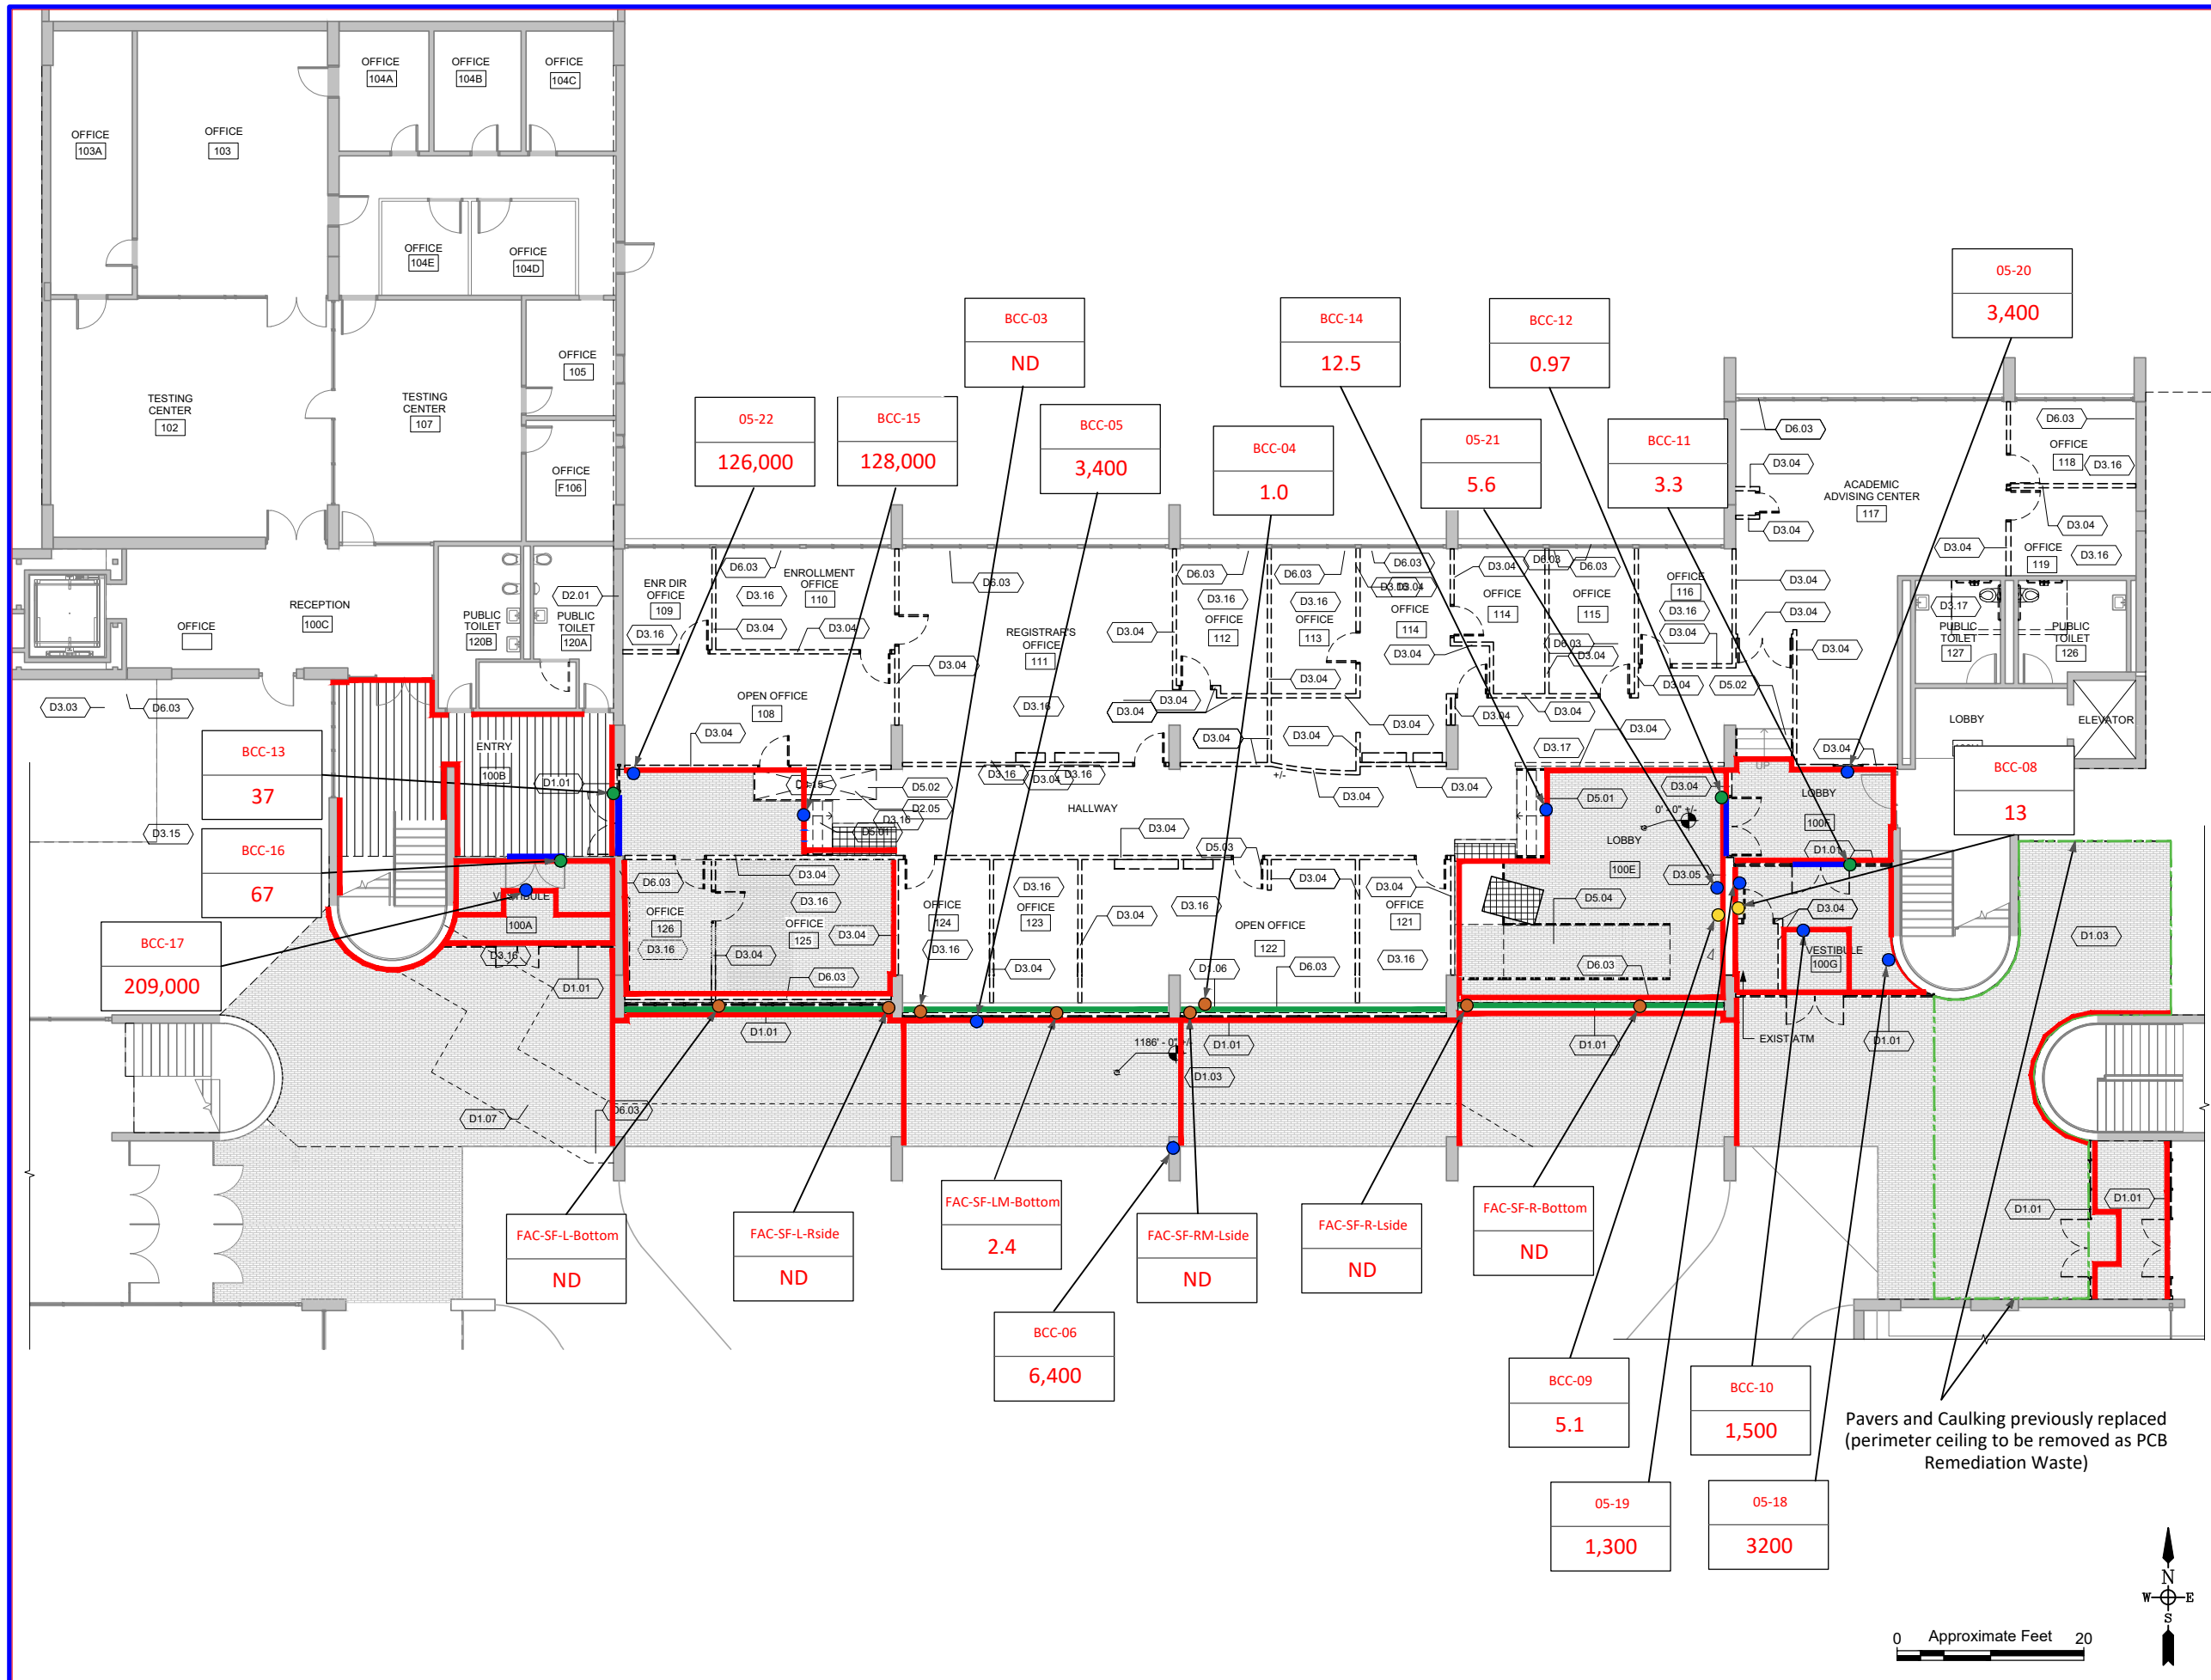
FIGURE NO.  
**3a**

The location where PCB-containing caulk exists in expansion joints in the brick paver areas are shown on Figure 3a. The caulking, brick pavers, mortar between bricks, and underlying granular sub-base material under the pavers will be removed and replaced with a new concrete floor slab.
